**USE OF MICRO UNMANNED AERIAL VEHICLES IN TRANSPORTATION
INFRASTRUCTURE CONDITION SURVEYS**

A Thesis

Major Subject: Civil Engineering

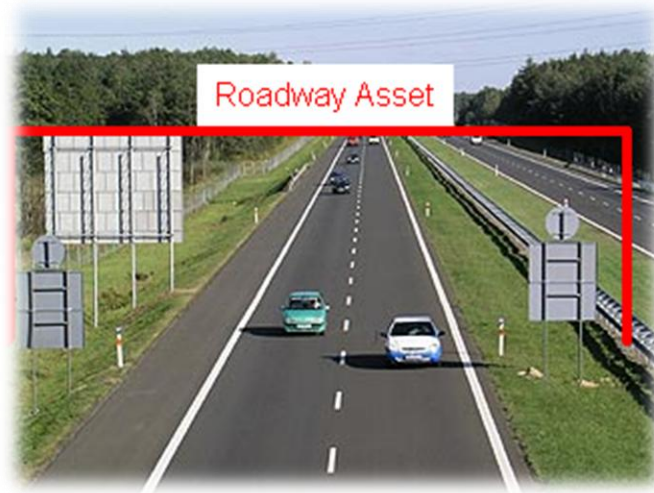
Figure 1.1. Roadside Area (Google Images)

Roadside areas are located between the edge of the roadway pavement and the right-of-way boundary line. This also includes the median located between divided multi-lane highways. Figure 1.1 shows the area that is considered to be a 'roadside' (excluding the actual pavement surface). Roadside assets and maintenance activities are diverse and have direct impact the safety of the travelling public and the proper use of the agency's resources. Example roadside assets and maintenance activities include culvert and storm drain maintenance, side ditch maintenance, barrier and guardrail maintenance, vegetation management, and litter pickup.

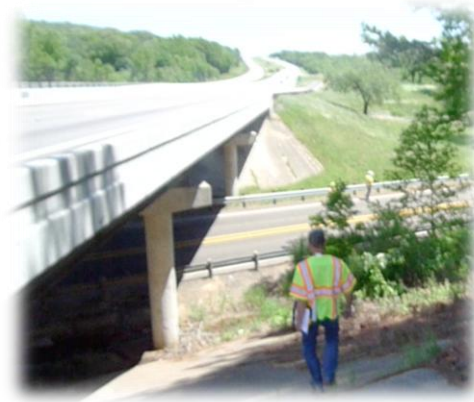
Figure 2.3. Demonstration of MUAV's Potential for Creating a Safer Work Environment.

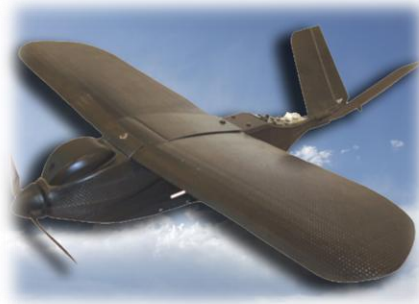
Figure 2.5. NightHawk MUAV Plane Type MUAV (ARA 2010).

A plane-configured MUAV (see examples shown in Figures 2.4 and 2.5) mimics that of a traditional single propeller driven aircraft. These MUAVs have the ability to fly a straight-line path and must be designed to obey the same laws of aero-dynamics that

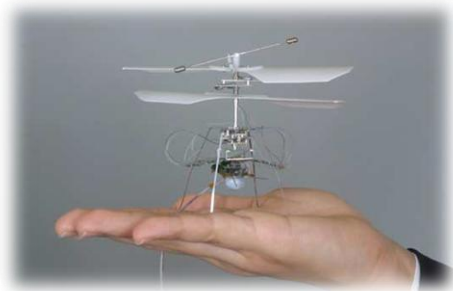
Figure 2.6. Telerobotics Helicopter MUAV (Telerobotics, 2009).

A helicopter-configured MUAV (see examples shown in Figures 2.6 and 2.7) utilizes upward thrust induced by a single or multiple propellers to maneuver in flight. This MUAV type does not need to maintain constant forward motion in order to stay airborne, and thus it has higher degree of freedom for movement. This design allows the MUAV to be much more compact. The typical size for helicopter-configured MUAV is approximately 2-3 ft diametrically. However, recent research has used nanotechnology to produce an insect-sized helicopter-configured MUAV (Newcome 2004). This technology is still limited to espionage and close quarter reconnaissance.

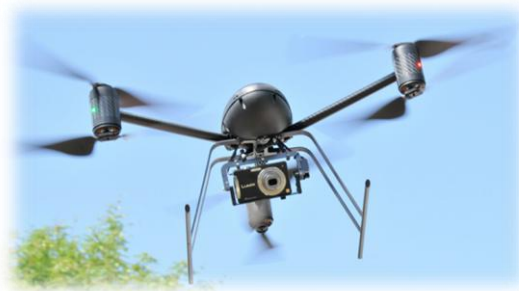
Figure 2.7. Dragan Fly X6 Helicopter MUAV (Dragan Fly, 2010).

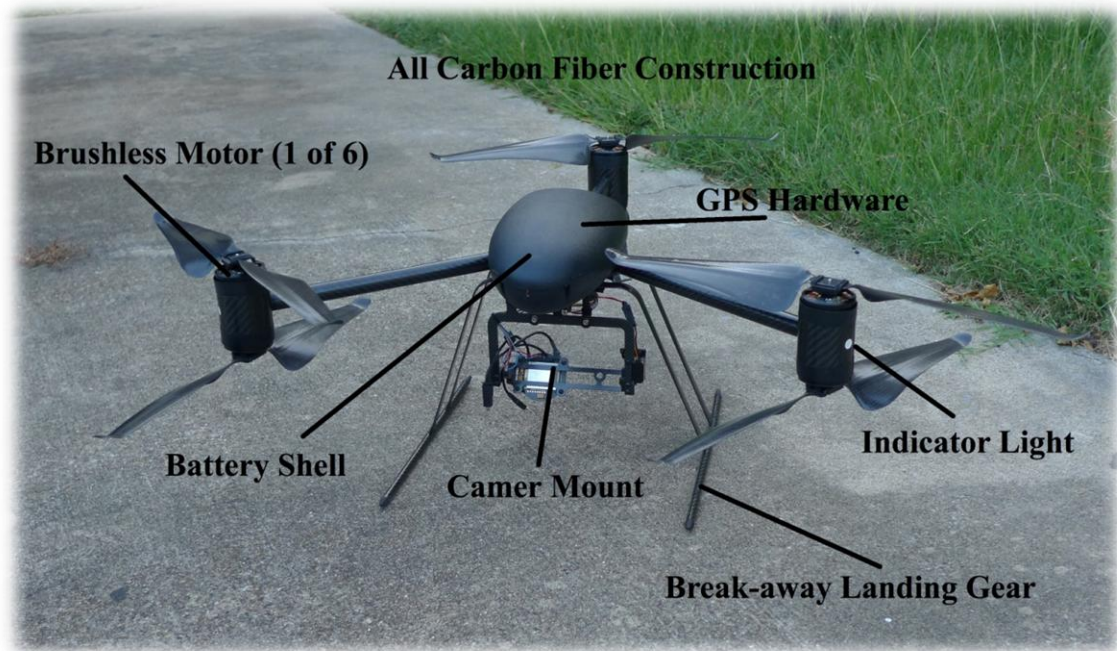
Figure 3.3 below shows a picture of the Dragan Fly X6 and labels some of its unique design features.

Figure 3.3 Dragan Fly Innovations X6 Helicopter MUAV.

Helicopter Size (Fully Assembled)	
Width	36 in.
Length	33 in.
Height	10 in.
Weight And Payload	
Helicopter Weight	2.2 lbs.
Payload Capacity	1.1 lbs.
Maximum Gross Takeoff Weight	3.3 lbs.
Flight Characteristics	
Unassisted Visual Reference Required	Path Entered Flight Capabilities
Max Climb Rate	23 ft/s
Max Descent Rate	13 ft/s
Max Turn Rate	90 °/s
Approximate Max Speed	30 mph
Minimum Speed	None
Launch Type	Vertical Take Off and Landing
Maximum Altitude	8,000 ft.
Max Flight Time	25 min.
Camera Type	
Still Camera	10 MP Digital Still
Motion Camera	720p High-Definition
Max Storage	2 GB
GPS	
Satellites Used	16
Position Update Rate	4 Hz
GPS Capabilities	Position Hold, Location Data

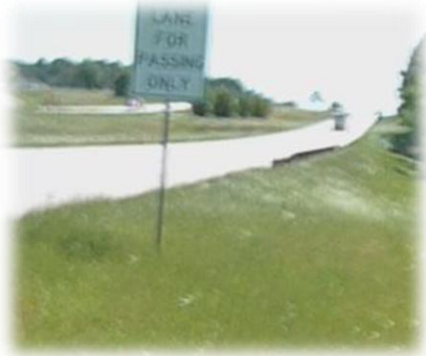
Figure 4.10. Sample Unit No. 2 MUAV Captured Image: Failed to Capture Guard Rail.

when the MUAV failed to capture a specific asset due to lack of visibility, clarity or maneuverability. To show exactly what happened during the rating process to cause the false reading, each of the 14 readings are shown in Appendix D side by side with a brief explanation of each case. Figures 4.10 and 4.11 show an example false MUAV reading. In this example, the last image in the video that the MUAV captured for Sample Unit No. 2. The image taken onsite shows that the guardrail is included in the sample unit (See Table A.1 for section reference). The MUAV was not able to capture the image of the guardrail due to tree and signage preventing maneuverability coupled with uncontrollable winds. Since the MUAV missed the guardrail (which met all performance standards), the other standards that received a failing rating carried impact on the overall condition of the sample unit, lowering the SS rating for the MUAV rating. It is worth noting that the images shown in this analysis were taken using the same HD digital camera. The wind jostles the MUAV around, which resulted in poor quality images. The quality of the images decreases as the wind speed increases.

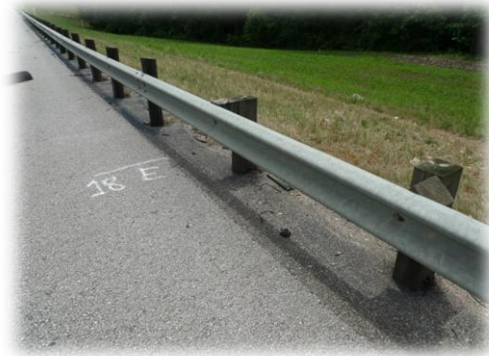
Figure 4.11. Sample Unit No. 2 Onsite Conditions: Guard Rail That Was Inspected.

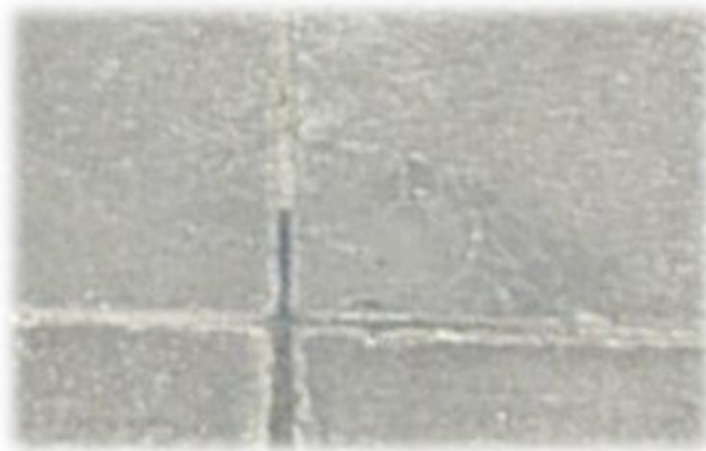
severity joint spalling, but when inspected by the onsite rater, this distress was found to be low-severity and sporadic. A close up of the joint shown in Figure 5.3 can be found in Figure 5.3 that shows the joint to only contain low severity joint spalling. The MUAV image mischaracterizes the discoloration of PCC slab at the joint as joint spalling.

Figure 5.2. Example of False Reading of Joint Spalling by MUAV (Image Captured by MUAV).

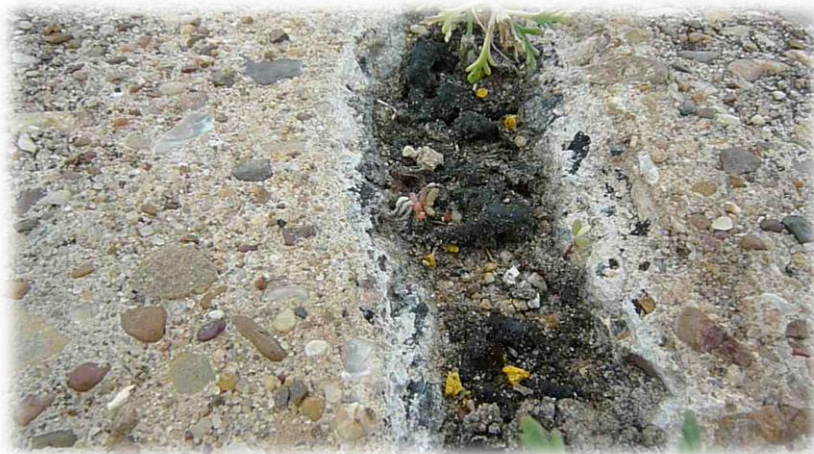
Figure 5.3. Onsite Conditions for Riverside Airfield Pavement, Low Severity Cracking.

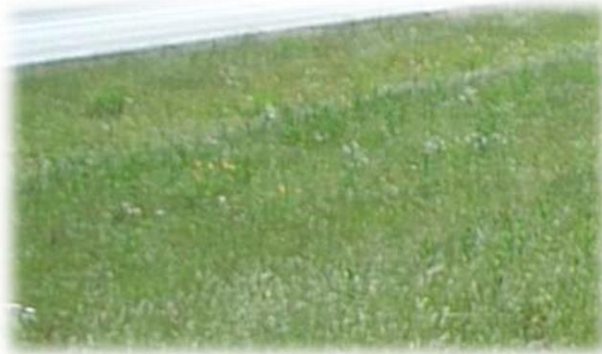
Figure D.1. Sample Unit No. 1 MUAV Captured Image: Ditch and Front Slope Passed Inspection.

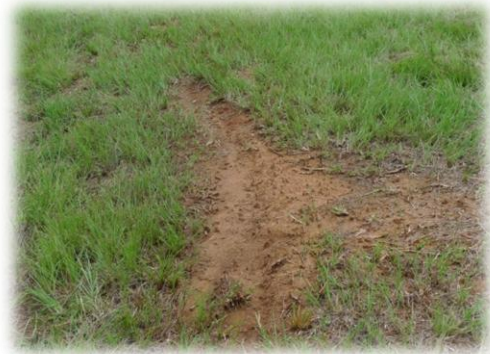
Figure D.2. Sample Unit No. 1 Onsite Conditions: Ditch and Front Slope Failed Inspection.

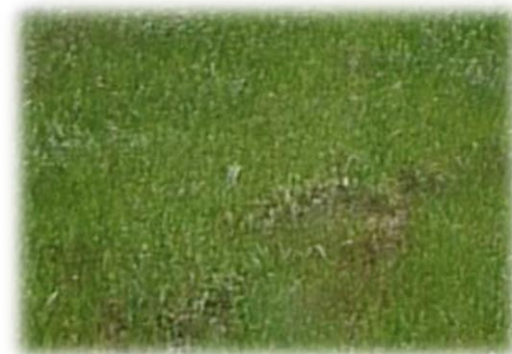
Figure D.3. Sample Unit No. 2 MUAV Captured Image: Ditch and Front Slope Failed Inspection.

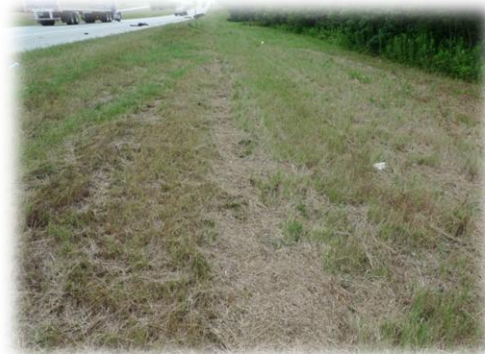
Figure D.4. Sample Unit No. 2 Onsite Conditions: Ditch and Front Slope Passed Inspection.

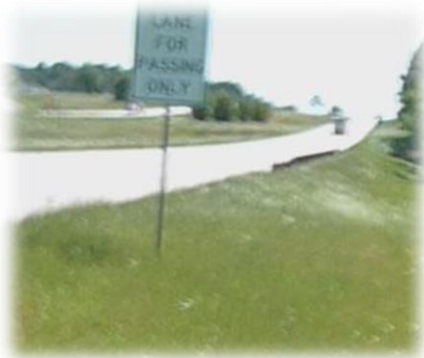
Figure D.5. Sample Unit No. 2 MUAV Captured Image: Failed To Capture Guard Rail.

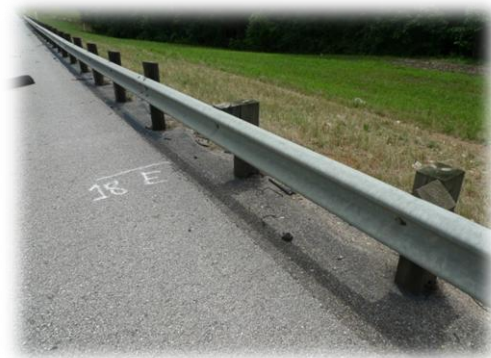
Figure D.6. Sample Unit No. 2 Onsite Conditions: Guard Rail That Was Inspected.

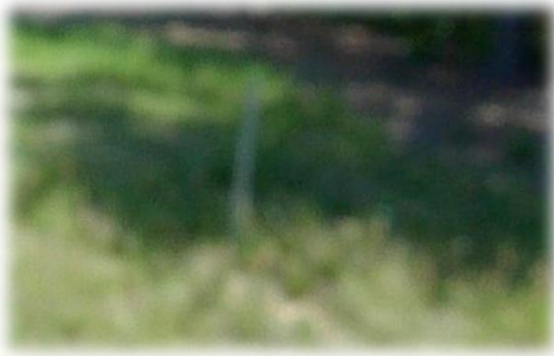
Figure D.7. Sample Unit No. 3 MUAV Captured Image: Failed to Capture Culvert and Drain Pipe.

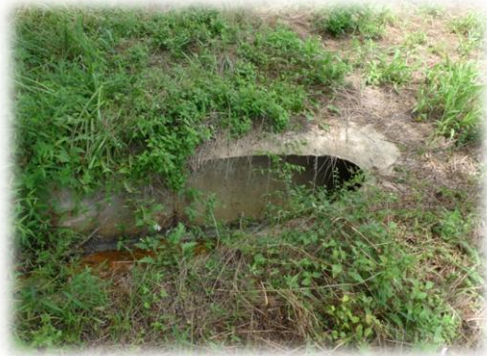
Figure D.8. Sample Unit No. 3 Onsite Conditions: Culvert and Drain Pipe That Was Inspected.

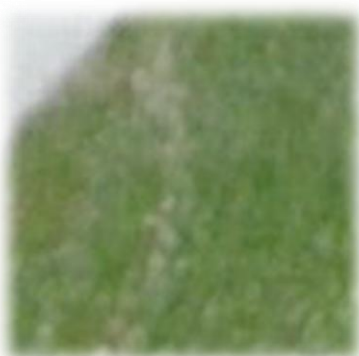
Figure D.9. Sample Unit No. 4 MUAV Captured Image: Ditch and Front Slope Failed Inspection.

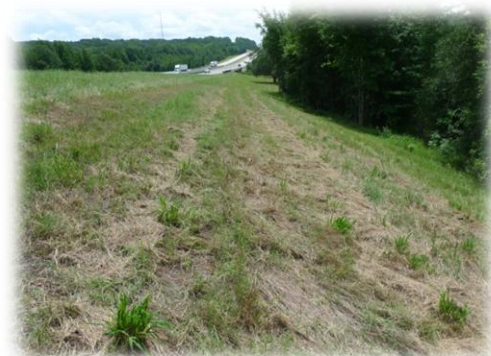
Figure D.10. Sample Unit No. 4 Onsite Conditions: Ditch and Front Slope Passed Inspection.

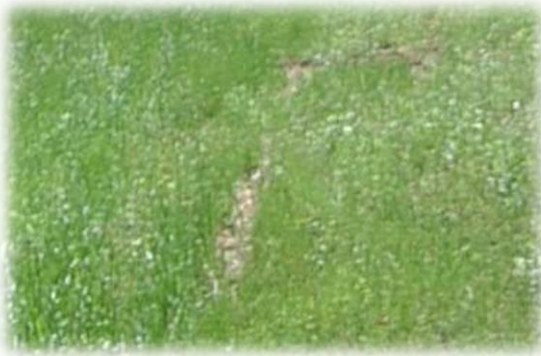
Figure D.11. Sample Unit No. 5 MUAU Captured Image: Ditch and Front Slope Failed Inspection.

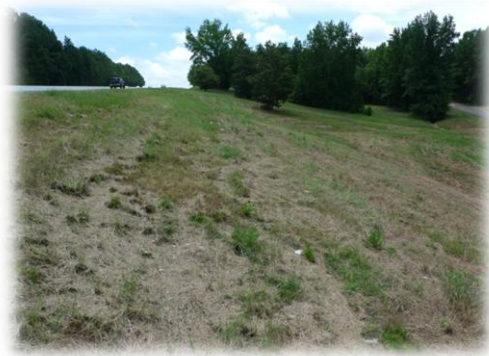
Figure D.12. Sample Unit No. 5 Onsite Conditions: Ditch and Front Slope Passed Inspection.

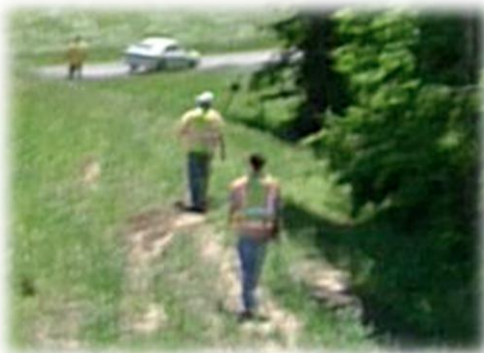
Figure D.13. Sample Unit No. 5 MUAU Captured Image: Failed to Capture Culvert and Drain Pipe.

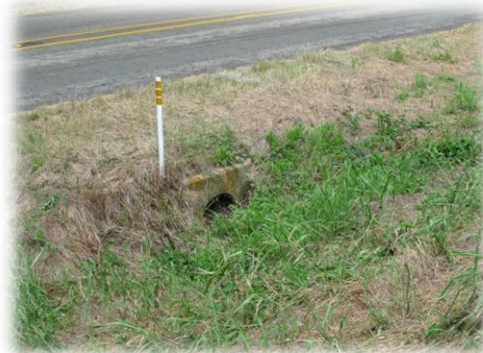
Figure D.14. Sample Unit No. 5 Onsite Conditions: Culvert and Drain Pipe That Was Inspected.

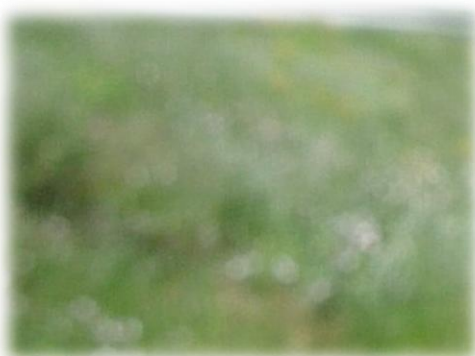
Figure D.15. Sample Unit No. 6 MUAU Captured Image: Ditch and Front Slope Failed Inspection.

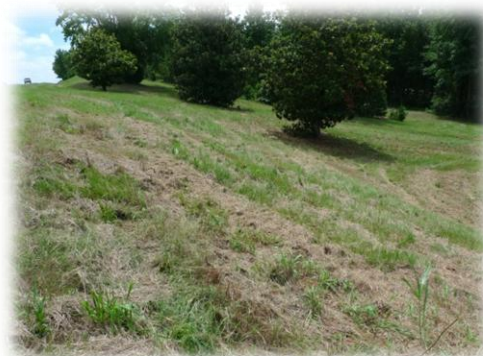
Figure D.16. Sample Unit No. 6 Onsite Conditions: Ditch and Front Slope Passed Inspection.

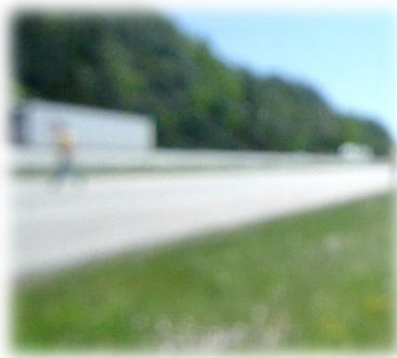
Figure D.17. Sample Unit No. 6 MUAV Captured Image: Failed to Capture Drain Inlet.

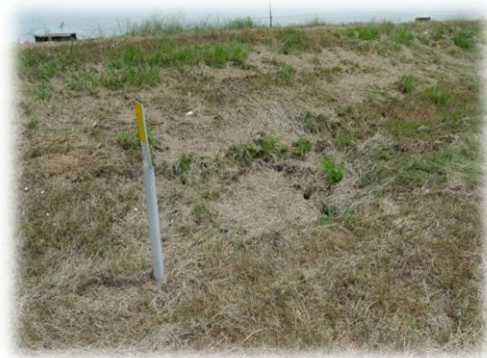
FigureD.18. Sample Unit No. 6 Onsite Conditions: Drain Inlet That Was Inspected.

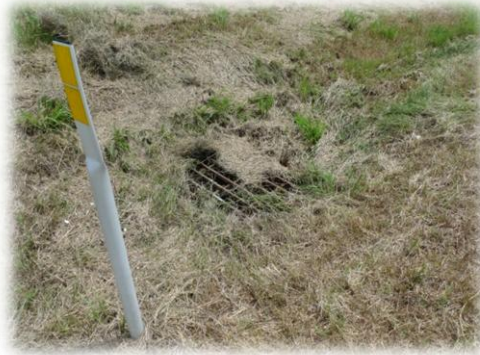
Figure D.19. Sample Unit No. 6 Onsite Conditions: Drain Inlet That Was Inspected (Uncovered).

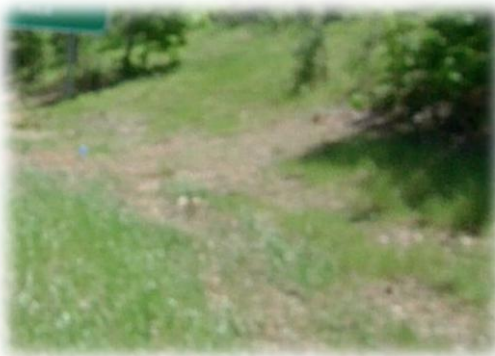
Figure D.20. Sample Unit No. 7 MUAV Captured Image: Ditch and Front Slope Failed Inspection.

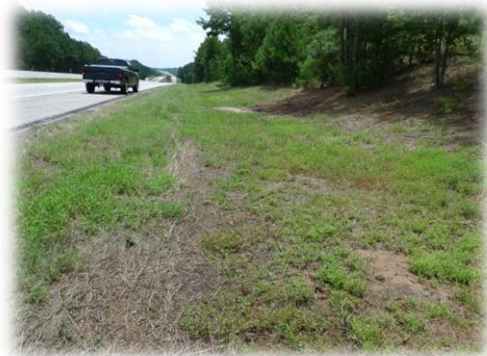
Figure D.21. Sample Unit No. 7 Onsite Conditions: Ditch and Front Slope Passed Inspection.

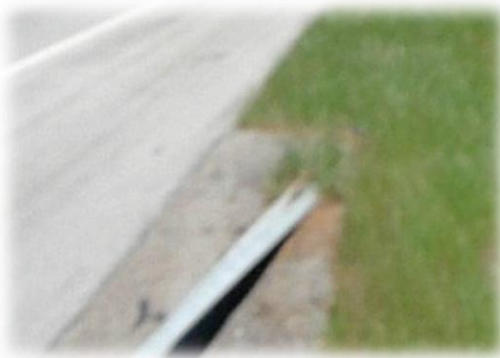
Figure D.22. Sample Unit No. 7 MUAV Captured Image: Failed to Capture Guard Rail.

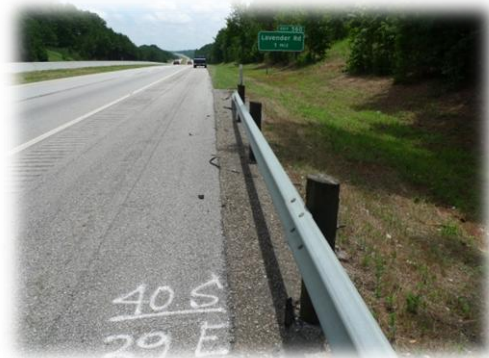
Figure D.23. Sample Unit No. 7 Onsite Conditions: Guard Rail That Was Inspected.

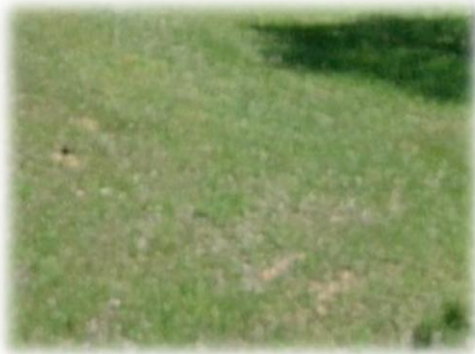
Figure D.24. Sample Unit No. 8 MUAV Captured Image: Ditch and Front Slope Failed Inspection.

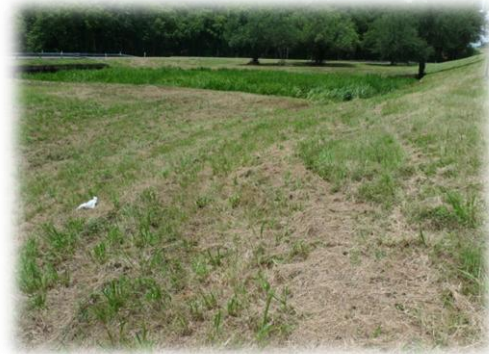
Figure D.25. Sample Unit No. 8 Onsite Conditions: Ditch and Front Slope Passed Inspection.

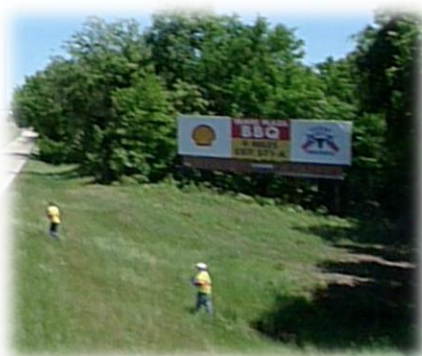
Figure D.26. Sample Unit No. 10 MUAV Captured Image: Failed to Capture Culvert and Cross Drain Pipe.

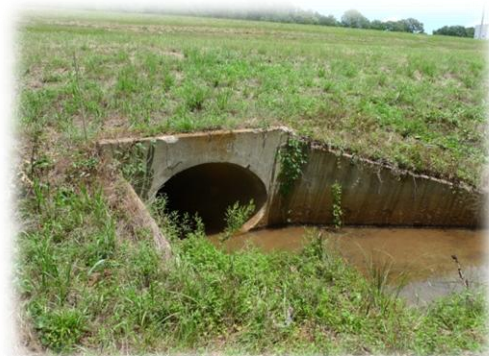
Figure D.27. Sample Unit No. 10 Onsite Conditions: Culvert and Cross Drain Pipe That Was Inspected.

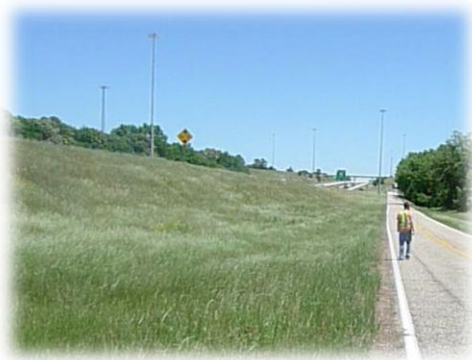
**Figure D.28. Sample Unit No. 10 MUAV
Captured Image: Failed to Capture Drain
Inlet.**

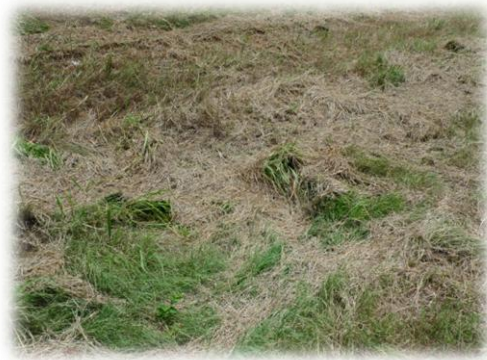
**Figure D.29. Sample Unit No. 10 Onsite
Conditions: Drain Inlet That Was
Inspected.**

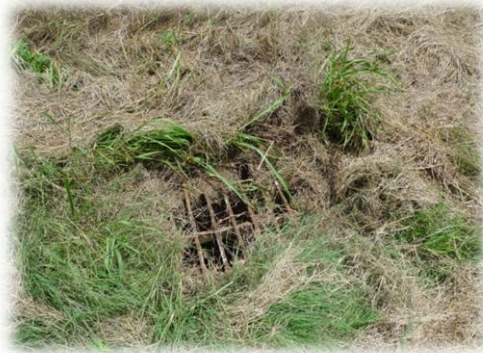
**Figure D.30. Sample Unit No. 10 Onsite Conditions: Drain Inlet That Was Inspected
(Uncovered).**
